Mobile Pentium® II Processor Specification Update

Release Date: October 1998

Order Number: 243887-003

The Mobile Pentium® II processor or the Intel® Pentium II Processor Mobile Module may contain design defects or errors known as errata which may cause the product to deviate from published specifications. Current characterized errata are documented in this Specification Update.

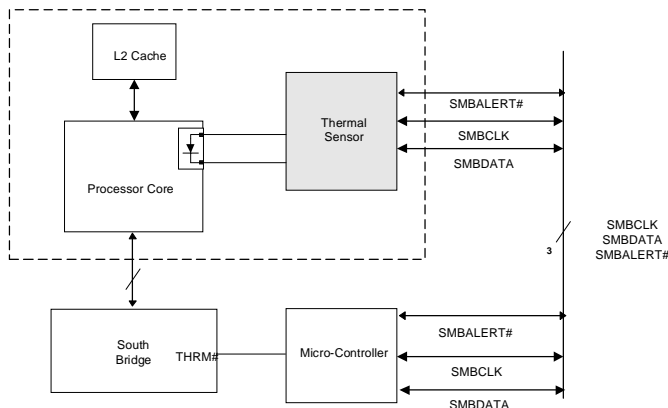
Figure 1. An Example of Micro-controller Driven Thermal Management

B30. Thermal Sensor May Assert SMBALERT# Incorrectly

PROBLEM: The Mobile Pentium II processor and the Pentium II processor Mobile Module have a thermal sensor that monitors the processor core's temperature. Please note that desktop systems could have a similar thermal device. The thermal sensor asserts SMBALERT# if the processor temperature exceeds the temperature limits set in the Alarm Threshold Registers (T_{HIGH} , T_{LOW}). It also sets the corresponding Status Register bits to identify the cause of the interrupt. Figure 1 gives one example of the how the SMBALERT# signal could be used in a system.

Under the conditions described below, the thermal sensor incorrectly generates the SMBALERT# interrupt. *All* of the following conditions must be met to trigger a false interrupt:
